## PFP Condition Survey and Fire Engineering Assessment

**Key words:** *unknown fire protection material, cementitious, fire resistance, fire engineering, regulatory approvals*

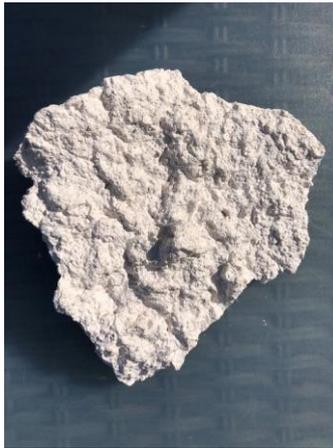
The initial visit failed to identify the product type visually, so samples were removed for further investigation, see Figure 1. Laboratory investigation revealed the material type and general constituents along with a density of product far greater than typical proprietary fire protection materials that would be used in buildings. This factor threw more confusion into an already difficult situation.

*Figure 1: Sample of the cementitious material, showing a rough texture and an off-white colour*

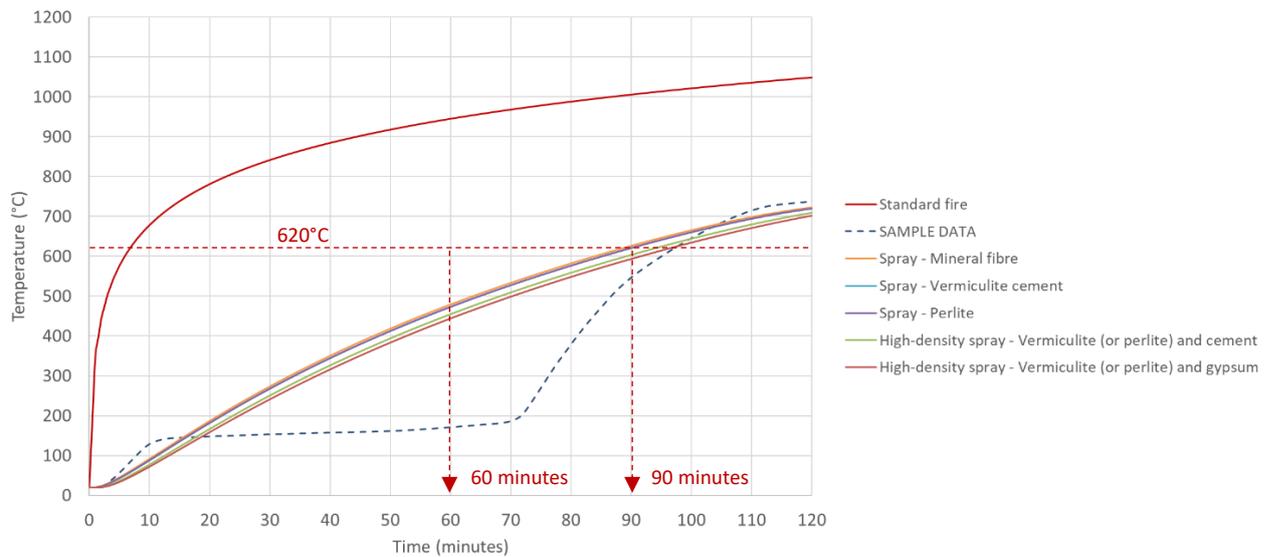
This required determination of the material's density, thermal conductivity, and specific heat properties, which included the effect of moisture content. Several representative structural members were selected from the project. For each member, its in-situ measured protection thickness was used together with the thermal material properties to undertake a heat transfer assessment to ascertain the temperature of the protected steelwork following exposure to the standard cellulosic fire. The resulting steel temperatures after 60 minutes were all shown to be lower than the structural member's default critical temperature.

The fire engineering heat transfer study and associated independent report was undertaken by PFPS' in-house Chartered Engineer. The outcome showed that the unknown fire protection material exhibited performance of a fire-resisting material which could be quantified against specific structural performance criteria to provide at least 60-minutes fire resistance as required by the project, see Figure 2.

Figure 2: Temperature history of a representative protected floor beam (the plateau represents the latent heat of vaporization of moisture). Temperature histories of the same beam with generic industry properties for cementitious-type coatings are also shown for indicative comparison.
